Introduction

This migration guide is designed to help you analyze the steps required to migrate from an existing SXX32F103 device to an MH2103A device. This document gathers the most important information and lists the important things to be aware of.

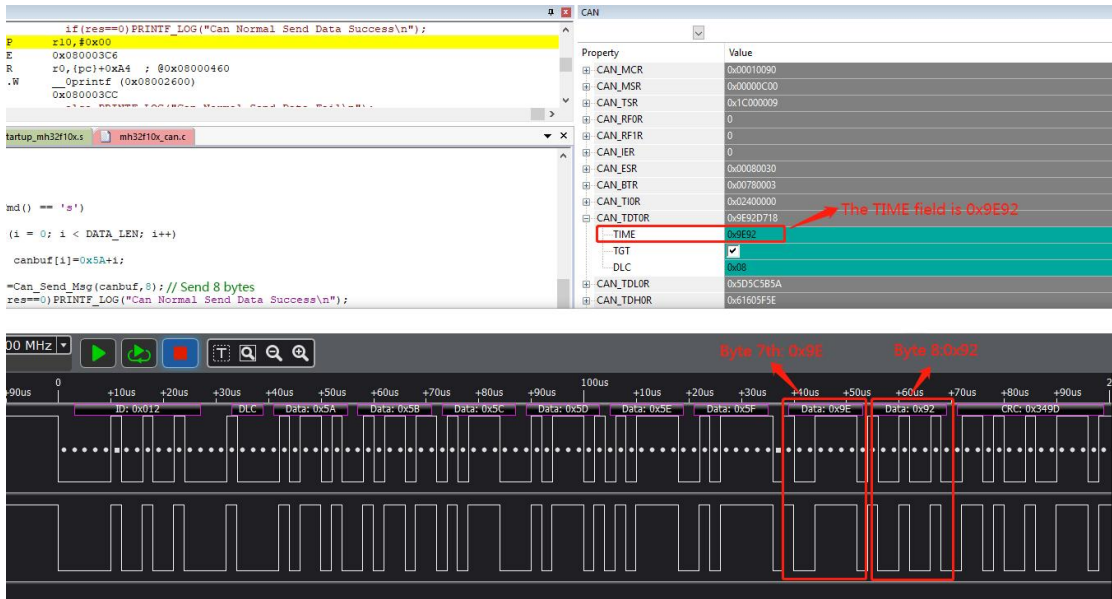
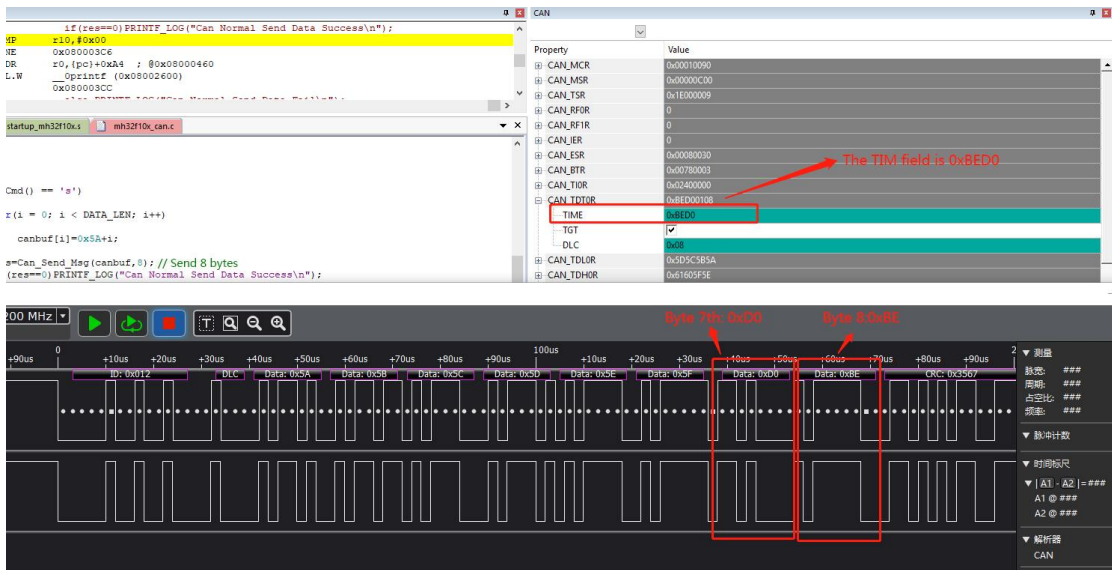
TIME[7:0] as the seventh byte and TIME[15:8] as the eighth byte replace the data written to CAN_TDHxR[31:16] (DATA6[7:0] and DATA7[7:0]).

TIME[7:0] as the eighth byte and TIME[15:8] as the seventh byte replace the data written to CAN_TDHxR[31:16] (DATA6[7:0] and DATA7[7:0]).

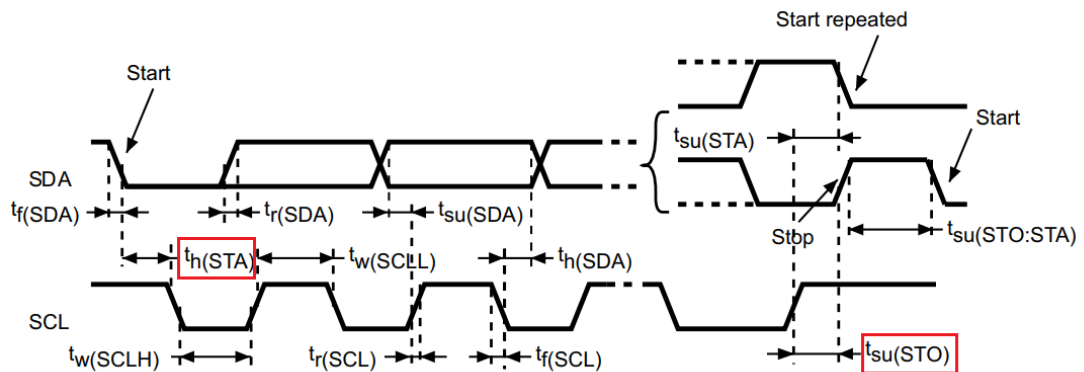
As shown in the figure below, the MH2103C start Hold time ($t_{h(STA)}$)&stop Hold time($t_{su(STO)}$)are different from SXX32F103.

When the peer end is an I/O analog Slave, check whether the peer end has requirements on $t_{h(STA)}$ and $t_{su(STO)}$.

$t_{h(STA)}$ and $t_{su(STO)}$ equals the high level time of the SCL.

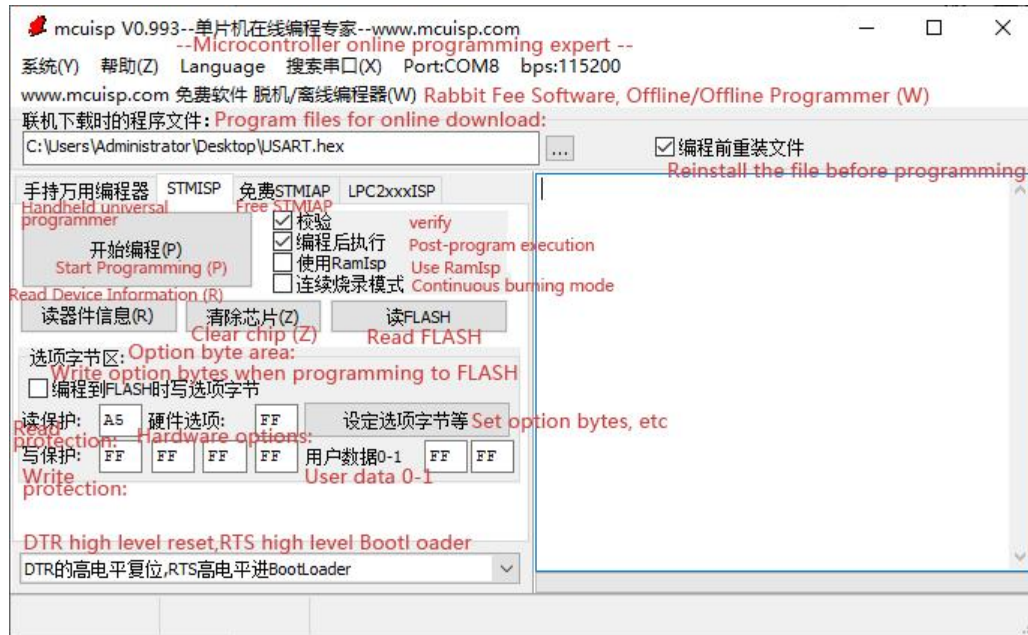
MH2103A does not support mcui sp V0.993.

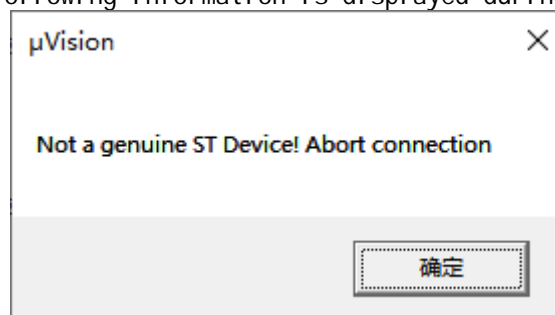
When using ULINK2 or CMSIS-DAP emulator and using pack package Keil.SXX32F1xx_DFP.2.3.0 or later (including version 2.3.0), the program cannot be downloaded. The following information is displayed during the download.

Solution:

Deselect the enable option in pack, as shown in the following figure.
