Introduction

This migration guide is designed to help you analyze the steps required to migrate from an existing SXX32F103 device to an MH2103C device. This document gathers the most important information and lists the important things to be aware of.

To port an application from the SXX32F103 series to the MH2103C series, users need to analyze hardware migration, peripheral migration, and firmware migration.

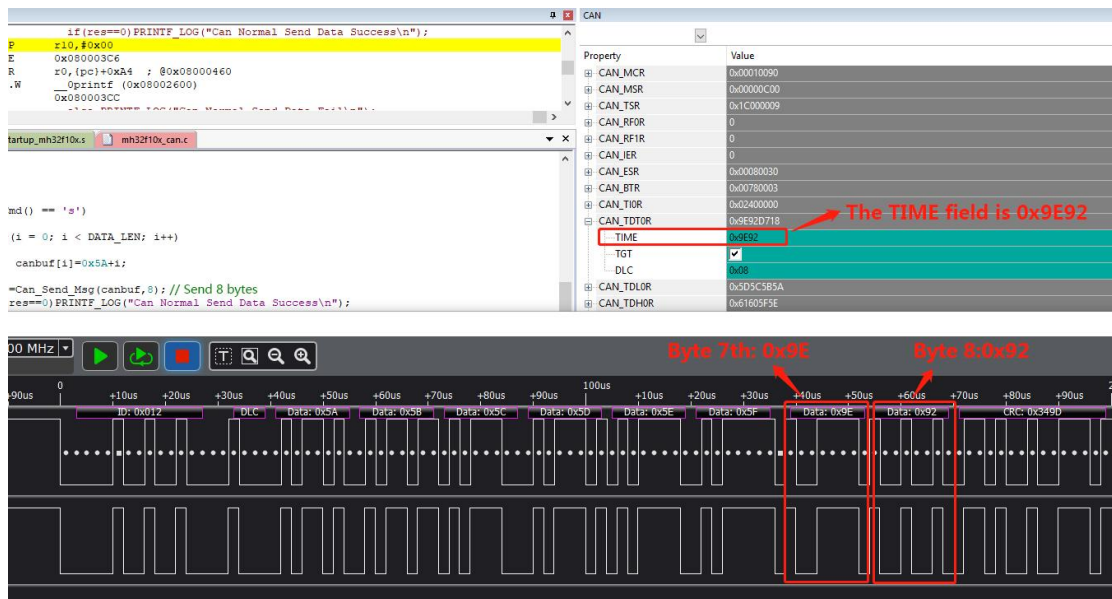
TIME[7:0] as the seventh byte and TIME[15:8] as the eighth byte replace the data written to CAN_TDHxR[31:16] (DATA6[7:0] and DATA7[7:0]).

Bit 31:16	TIME[15:0]: Message time stamp This field contains the value of the 16-bit timer at the time the packet is sent.
Bit 15:9	Reserved bit
Bit 8	TGT: Transmit global time This bit is only valid if CAN is in time-triggered communication mode, i.e. the TTCM bit of the CAN_MCR register is '1'. 0: does not send timestamp TIME[15:0]; 1: Send timestamp TIME[15:0]. In a packet of length 8, the timestamp TIME[15:0] is the last two bytes sent: TIME[7:0] as the seventh byte and TIME[15:8] as the eighth byte replace the data written to CAN_TDHxR [31:16] (DATA6[7:0] and DATA7[7:0]). In order to send out 2 bytes of the timestamp, the DLC must be programmed to 8.
Bit 7:4	Reserve the bit
Bit 3:0	DLC[15:0]: Send Data length code This field specifies the data length of the data message or the data length of the remote frame request. A message contains 0 to 8 bytes of data, which is determined by the DLC.

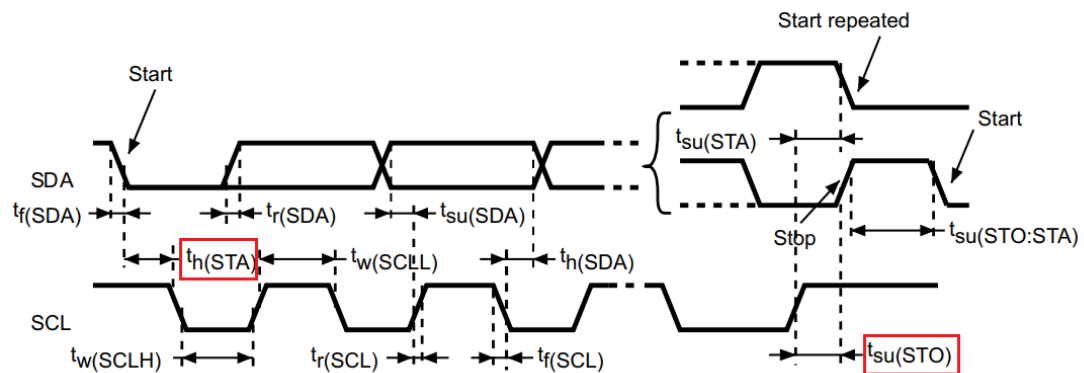
As shown in the figure below MH2103C start bit Hold time ($t_{h(STA)}$)&stop bit Hold time($t_{su(STO)}$)and SXX32F103 is different.

When the peer end is an I/O analog Slave, you need to confirm whether the peer end has requirements for $t_{h(STA)}$ and $t_{su(STO)}$.

For SXX32F103:

$t_{h(STA)}$ and $t_{su(STO)}$ equal the high level time of the SCL.

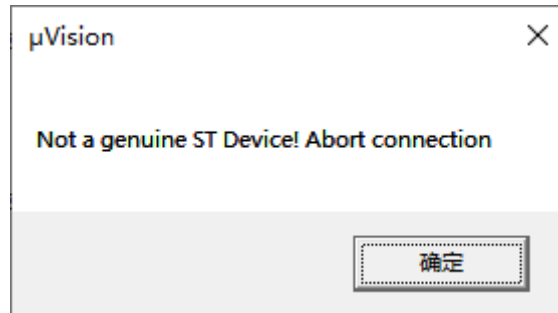
When using ULINK2 or CMSIS-DAP emulator and using pack package Keil. SXX32F1xx_DFP.2.3.0 or later (including version 2.3.0), the program cannot be downloaded. The following information is displayed during the download.

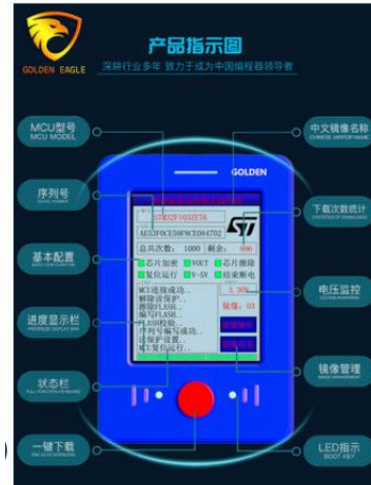
At present, there are many downloader manufacturers on the market, and MH2103C fully supports the downloader: Jindiao offline downloader
